NASA TN D-4282

VISUAL OBSERVATIONS OF FLOW THROUGH A RADIAL-BLADED CENTRIFUGAL IMPELLER

by Richard F. Soltis and Max J. Miller

*Lewis Research Center
Cleveland, Ohio*

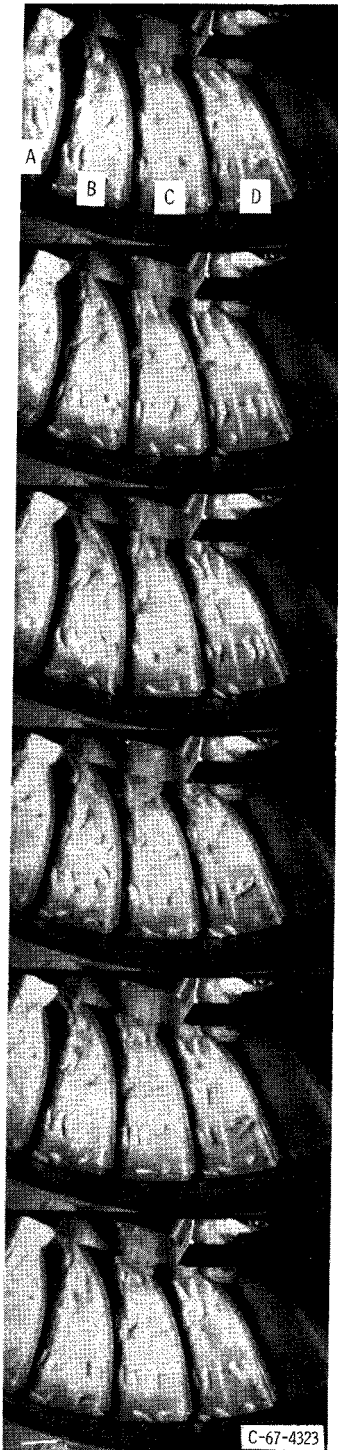
Figure 13. - Film sequence showing behavior of tufts at below-design flow coefficient of 0.075.

At $\overline{\varphi}$ equal to 0.075 (fig. 13), where $\overline{\varphi}/\varphi_d$ is only 0.21, the following observations were made:

(1) The tufts in all passages exhibit large changes from their normal position to indicate a very unstable flow. (This instability is shown better in the motion-picture sequence.)

(2) The flow reversals are even larger than at $\overline{\varphi} = 0.170$ as shown by the number of tufts in all passages that indicate flow toward the blade inlet. The tufts remain in this position for a greater number of motion picture frames.

(3) Passage D again seems to be the passage carrying the most through flow, as indicated by the tufts turned toward the outlet in that passage.

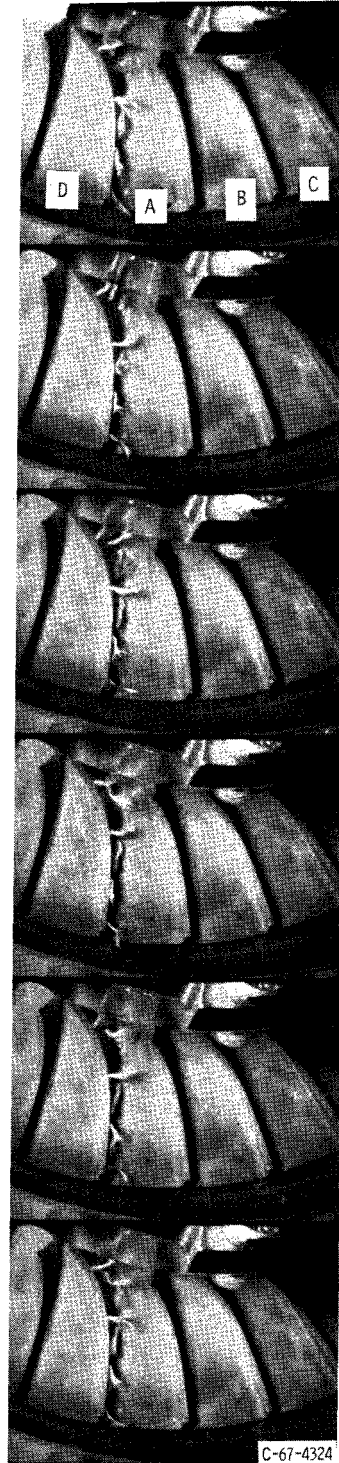
Figure 14. - Film sequence showing positioning of tufts on blade suction surface at low flow coefficient of 0.075.

At this flow coefficient ($\overline{\varphi} = 0.075$), the set of tufts on the suction surface of a main blade were also photographed (fig. 14). These tufts indicate separation at all radii in the blade leading-edge region. Separation is not as pronounced towards the trailing edge, especially along the hub of the blade. The operator noted that, at the low flows, these suction-surface tufts over the entire blade illustrated an unsteady condition by fluctuating back and forth in a seemingly random fashion.

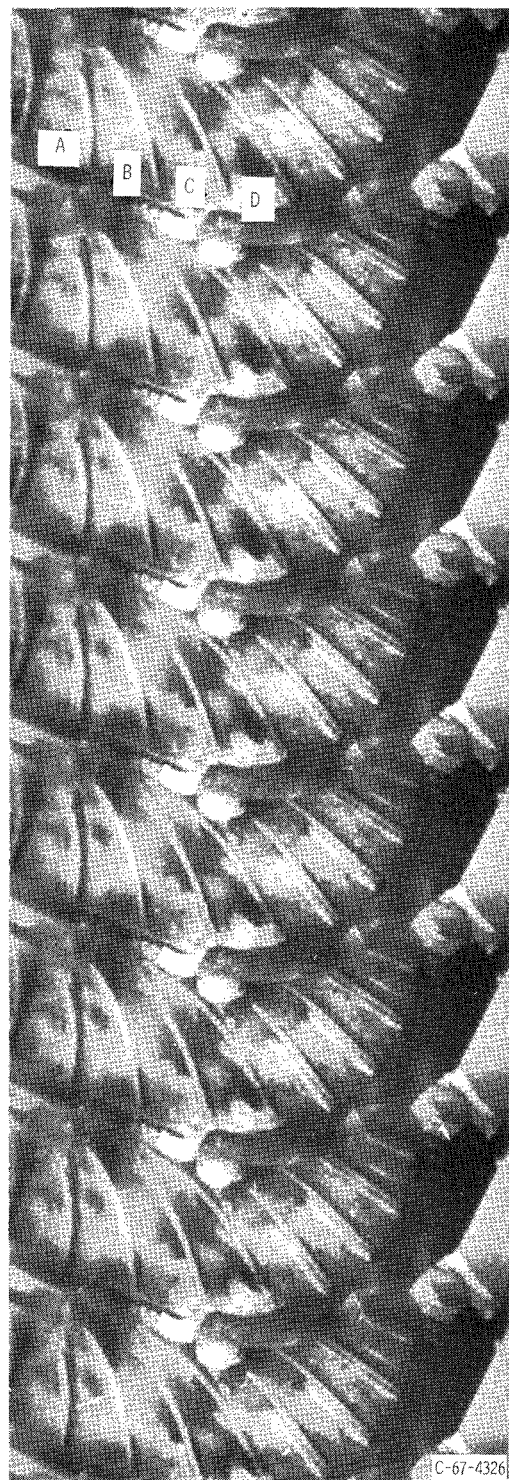
(a) Below-design flow coefficient, 0.170.

(b) Below-design flow coefficient, 0.075.

Figure 16. - Film sequence showing dye in blade passages.

At a flow coefficient of 0.170 (fig. 16(a)), the flow appears to be separating from the main blade and the main splitter blade and flowing primarily through passages B and D, again in agreement with the tuft observations. When the flow is reduced to $\bar{\phi} = 0.070$ (fig. 16(b)), small amounts of fluid seem to be flowing in a region close to the pressure surfaces of passages C and D. Passages A and B seem to receive little fluid. The motion-picture sequence of the dye injection better illustrates these flow conditions within the impeller. From this sequence, the flow is seen to exhibit a circulatory motion along with the through flow within a single blade passage. In the tuft sequences, however, this phenomenon was observed by the fluctuation of the tufts within the various passages.

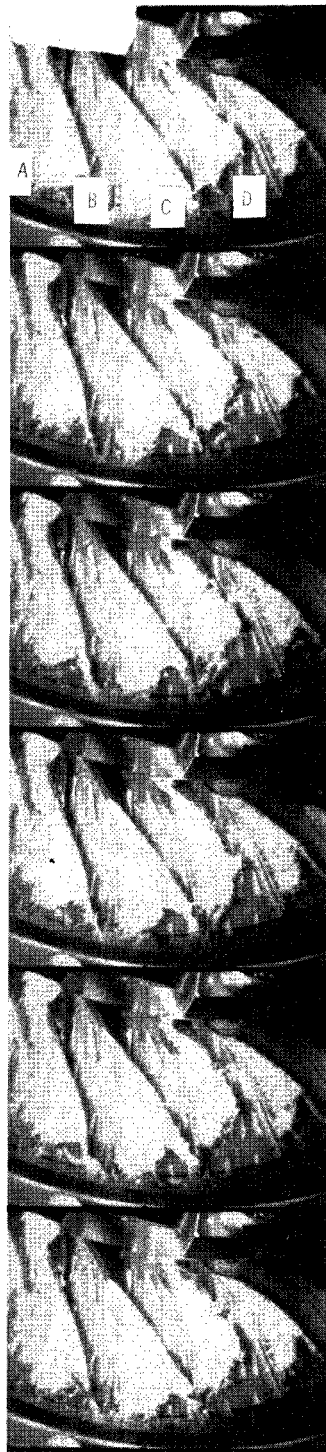
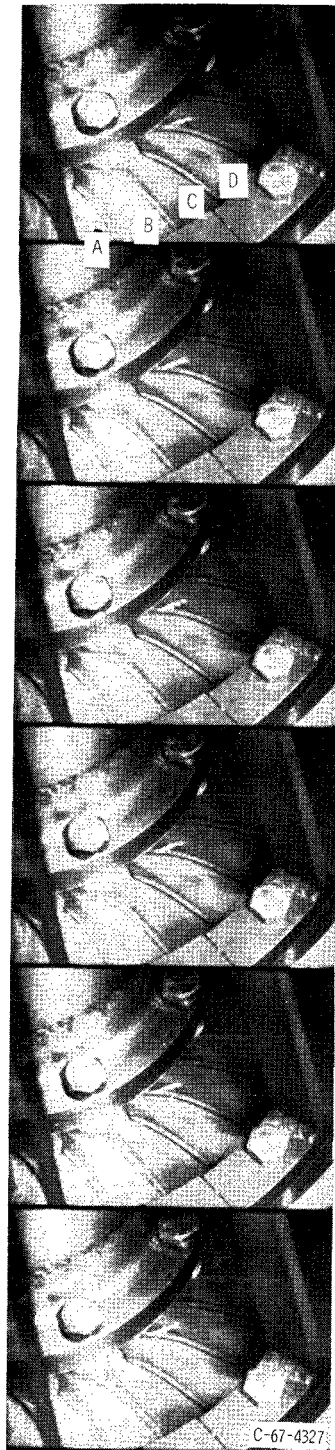
(a) In diffuser tongue region.

(b) At 180° from diffuser tongue.

Figure 18. - Film sequence showing cavitation within impeller at high flow coefficient of 0.602.

At a flow coefficient of 0.602, visual observations indicated that, in the vicinity of the diffuser tongue, a significant amount of cavitation was occurring within the impeller (fig. 18(a)). However, on the opposite side of the impeller housing (fig. 18(b)), a negligible amount of cavitation was observed within the blade passages to indicate that the degree of cavitation is not constant around the periphery of the impeller. This variance of cavitation results from the peripheral gradient of back pressure placed on the impeller as a result of the off-design flow around the scroll. It is not clear to what extent the cavitation and the peripheral gradient of impeller performance may be contributing to the fluctuating pressure measurements.
